## DiamondWrap® HP™ 12” Damaged Elbow Repair in Canada

**Customer:** Natural Gas Storage, Transmission, and Distribution Company

**Pipe Diameter:** 12”

**Pipe Defect:** External Corrosion, Gouges, and Arc Burns on a Gas Transmission Elbow

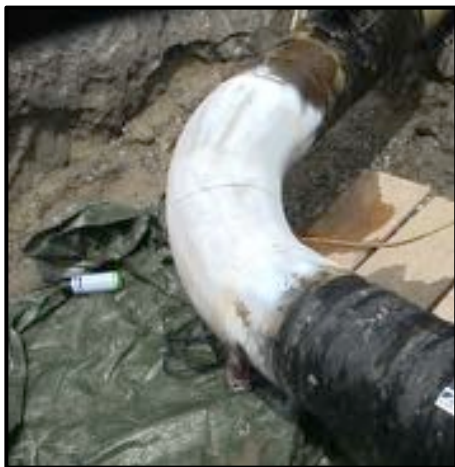
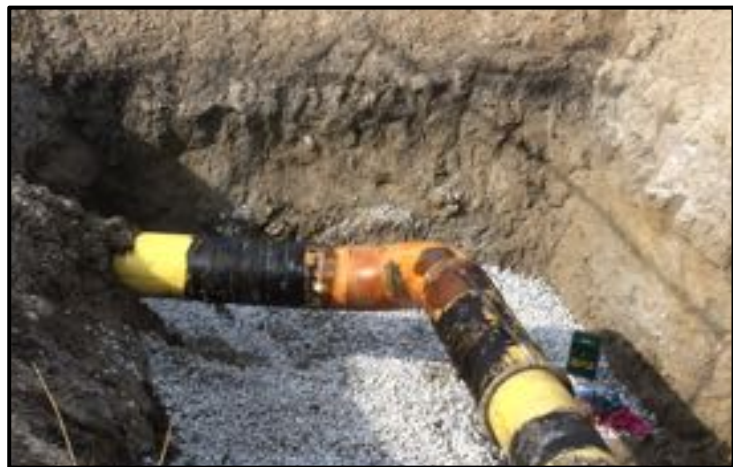
This gas cogen line was suffering from external corrosion, gouges, and arc burns. Many miles of pipeline would have to be blocked in and purged in order to cut the line and weld in a fresh section of pipe, costing the company hundreds of thousands of dollars. Additionally, the configuration that required repair consisted of two 45 degree elbows that changed the depth and direction of the pipeline. This configuration is not repairable with welded sleeves, and other traditional repair methods such as a clamp would not be as easily installed. A rigid composite repair system would also not be feasible. The result would be a costly repair with heavy equipment and lots of hot work, lost production time, and lost gas. Following are pictures of the damaged pipe.

Citadel Technologies’ team of engineers designed repairs for each defect according to ASME PCC-2 Article 4.1, and recommended a DiamondWrap® HP™ repair solution. Only 4 layers of DiamondWrap® HP™ were required to repair the defect, even with the high design pressure.

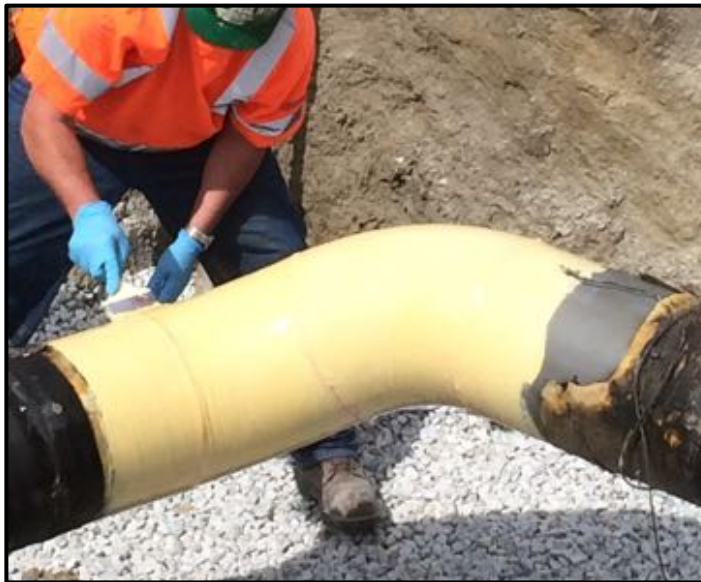
Applying the primer

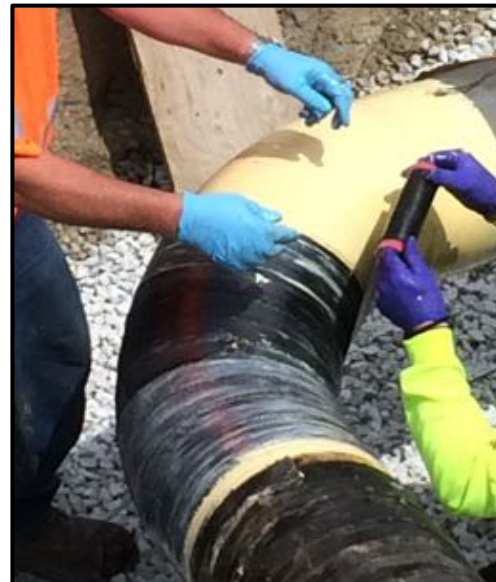
Installing DiamondWrap® HP™

Citadel conducted on-site training for employees of the natural gas company and the contractor within a half day. The following day, a supervisor from Citadel looked on as the newly certified installers applied each step of the process. The high compressive modulus filler putty was installed in the defect areas and around the welds to transfer the load to the carbon fiber repair system. The primer was installed next to increase the bond between the repair and the pipe. Finally, 4 layers of carbon fiber were installed over the both 45 degree elbows.
