# DiamondWrap® HP™ 16” Dented/Gouged Natural Gas Pipeline

**Customer:** Natural Gas Transmission Pipeline Operator

**Pipe Diameter:** 16”

**Pipe Defect:** Dent and gouge extending approx. 130” axially along the pipe

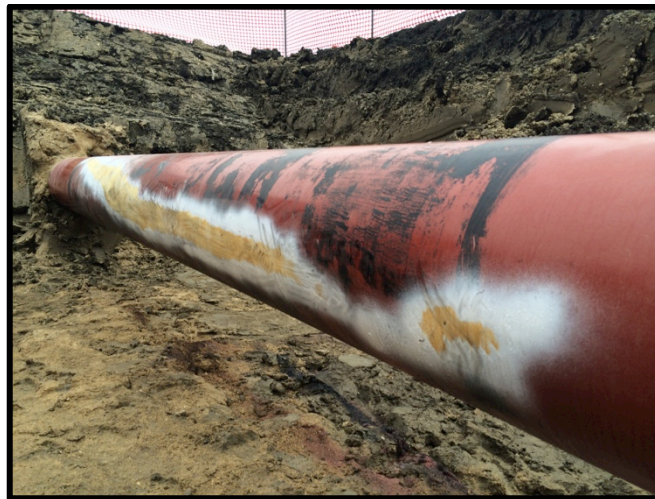
A natural gas transmission pipeline operator approached Citadel Technologies with a gas pipeline that had been damaged by road construction nearby. The loss of integrity required a repair solution to ensure a safe environment for the nearby population, and operational restrictions were not conducive for a shutdown.

Citadel Technologies' team of highly skilled engineers designed a repair according to ASME PCC-2 Article 4.1, and recommended a DiamondWrap® HP™ repair solution to the customer. Only 4 layers of DiamondWrap® HP™ were required to repair the defect.

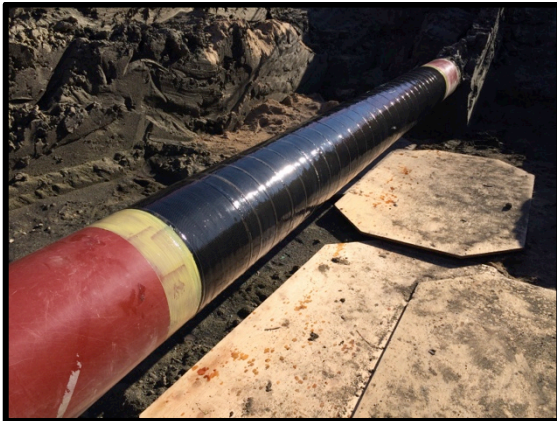
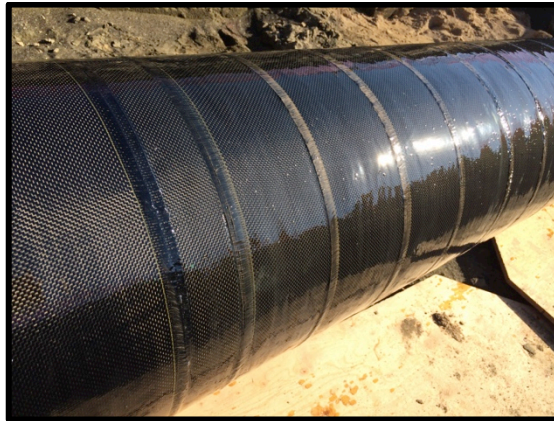
A team of trained and certified installers installed 4 layers of carbon fiber over the specified repair area, according to the calculations prepared by the Citadel Technologies engineer. The repair cured overnight, and the ends were wrapped with a tape to prevent CP leakage. Below are photos of the completed repair:
