## BlackDiamond® 24” Field Bend Dent Repair in USA

**Customer:** Gas Transmission and Distribution Pipeline Owner and Operator

**Pipe Diameter:** 24”

**Pipe Defect:** Dent in Field Bend

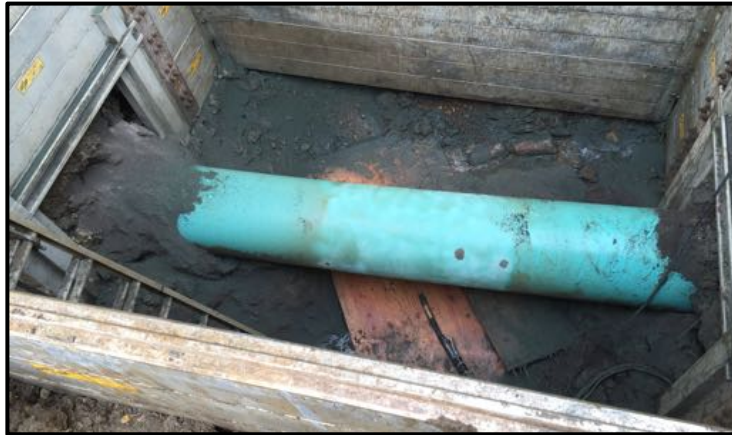
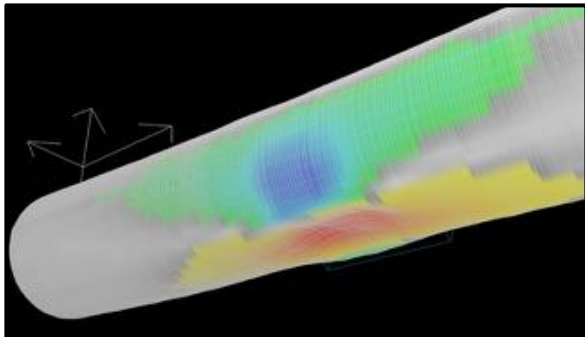
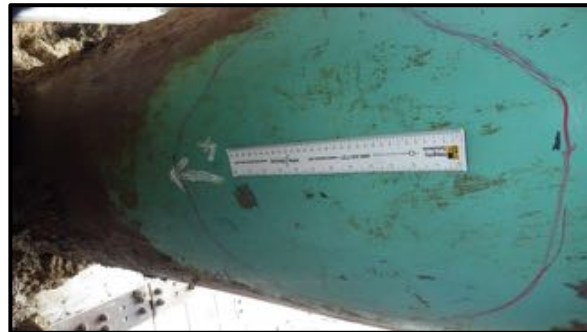
An advanced In-Line Inspection (ILI) tool was passed through a 24” natural gas transmission pipeline in a mountainous terrain in the USA operating at 720 psi MAOP. The operator could not afford to shut down the line to cut and replace because of the high transport volume through the pipe. Additionally, a welded sleeve could not be used because of the odd configuration of the pipe in the area, and it would have added hundreds of thousands of dollars of cost and down time. Pictures of the surrounding terrain and the anomaly are below.

Citadel Technologies' team of project engineers designed a permanent repair for the dent according to relevant equations in ASME PCC-2 Article 4.1, and recommended a BlackDiamond® repair solution. 8 layers of BlackDiamond® were required to permanently repair the defect.

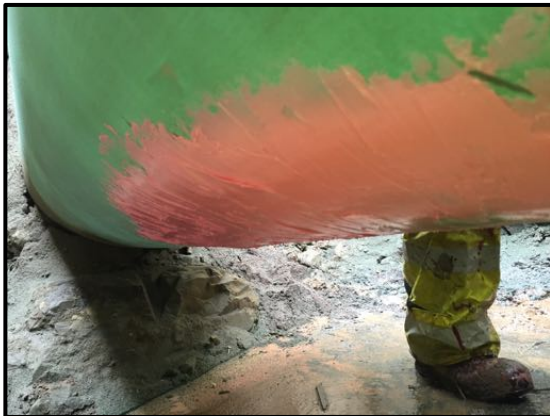
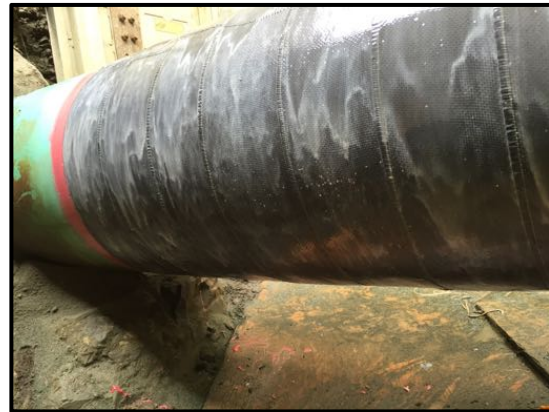
Before and after of repaired dented area
