DiamondWrap® HP™ 8” Field Bend Corrosion Repair – USA

Customer: Natural Gas Transmission Operator

Pipe Diameter: 8”

Pipe Defect: Severe External Corrosion and Pitting

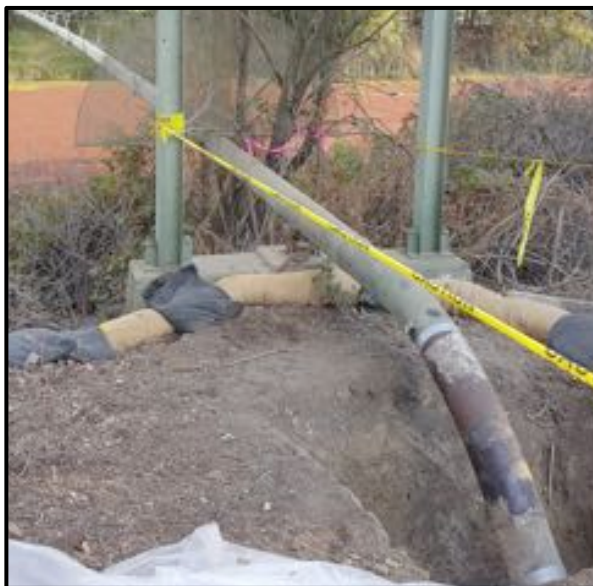
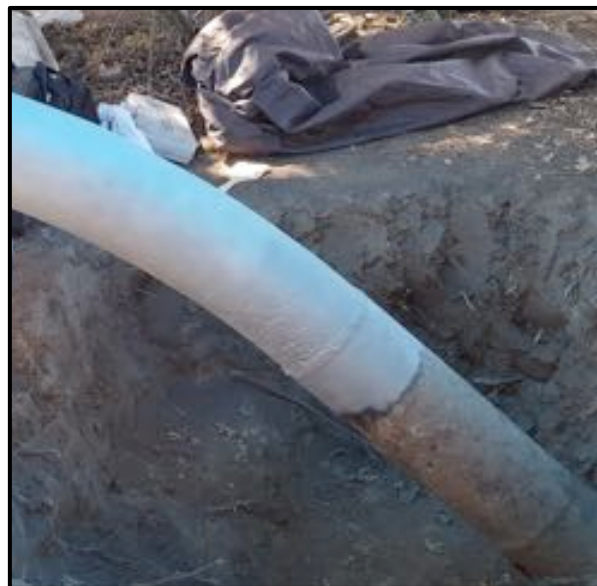
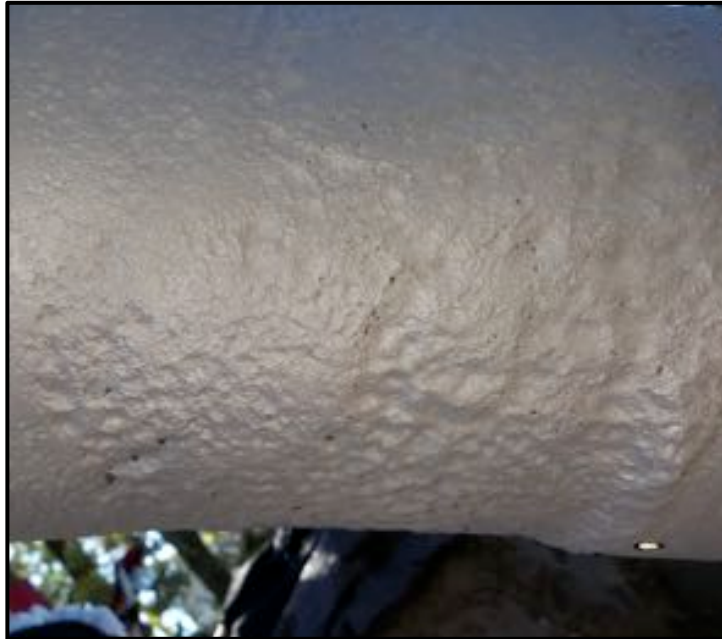
A natural gas transmission operator found severe external corrosion up to 71% wall loss on two field bends on each end of a river crossing. In addition to the corrosion, the weight of the pipe and the corresponding bending and axial forces were also of a concern to the operator. In this case, a welded sleeve could not be used because of the odd configuration of the pipe in the area, and it would have added hundreds of thousands of dollars of cost and down time to cut and replace the pipe. Pictures of the corroded pipe and the anomaly are below.

Citadel Technologies’ team of project engineers designed a permanent repair for the corrosion according to relevant equations in ASME PCC-2 Article 4.1, and recommended a DiamondWrap® HP™ repair solution. The customer required that the final design take into account the bending and axial forces, as well as the forces exerted due to thermal expansion and contraction. Once the analysis was completed, Citadel’s engineers determined that 4 layers of DiamondWrap® HP™ were required to permanently repair the defects based on the given conditions in the engineering assessment.
