## BlackDiamond® 24” Field Bend Dent Repair in USA

**Customer:** Gas Transmission and Distribution Pipeline Owner and Operator

**Pipe Diameter:** 24”

**Pipe Defect:** Dent in Field Bend

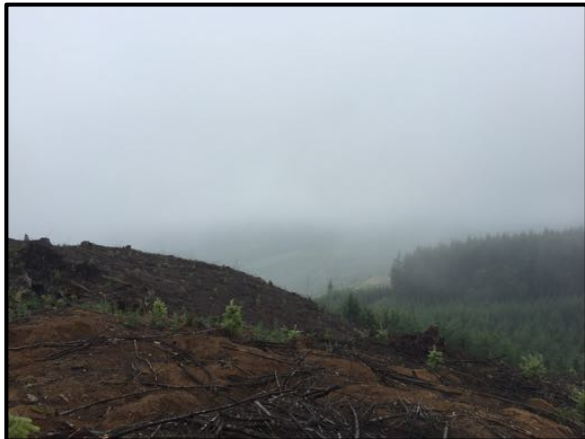
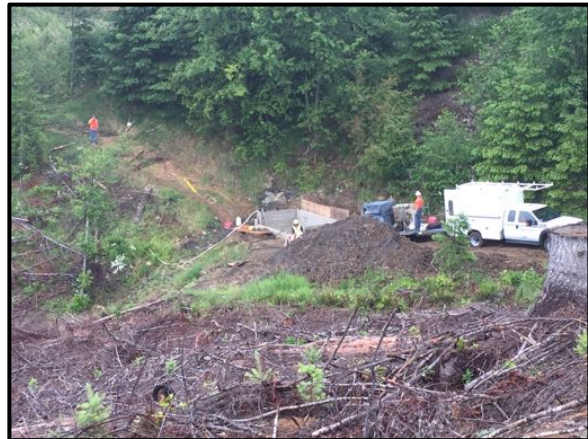
An advanced In-Line Inspection (ILI) tool was passed through a 24” natural gas transmission pipeline in a mountainous terrain in the USA operating at 720 psi MAOP. The operator could not afford to shut down the line to cut and replace because of the high transport volume through the pipe. Additionally, a welded sleeve could not be used because of the odd configuration of the pipe in the area, and it would have added hundreds of thousands of dollars of cost and down time. Pictures of the surrounding terrain and the anomaly are below.
